# Manhole Inspection Summary

Manhole # S23I\_\_043MH

**Location** Address: **105-107 Lemmon st**

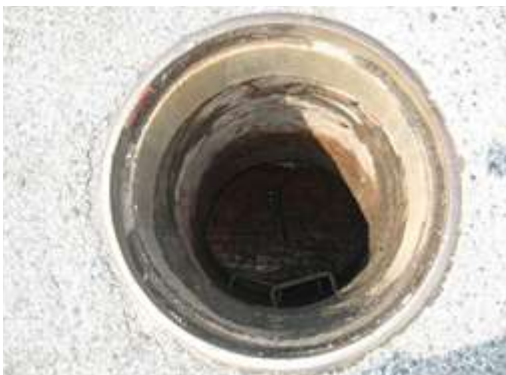
Defect

Offset: **1.** (in.)  
**75**

Condition: ☐ Sound ☐ Cracked ☒ **Leaks**

frame offset 1.75"

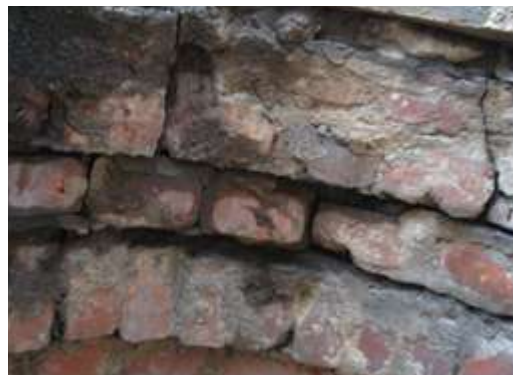
Defect 3

Condition: ☐ Sound ☒ **Cracked** ☐ Root Intrusion ☒ **Loose Brick** ☐ Deteriorated

Infiltration: ☐ None ☒ **Joint** ☐ Cracks ☒ **Mortar** ☐ Roots ☐ Wall

Infiltration: ☐ None ☐ Joint ☐ Cracks ☒ **Mortar** ☐ Roots ☐ Wall

Cracks, loose bricks in chimney and corbel, infiltration in chimney and corbel

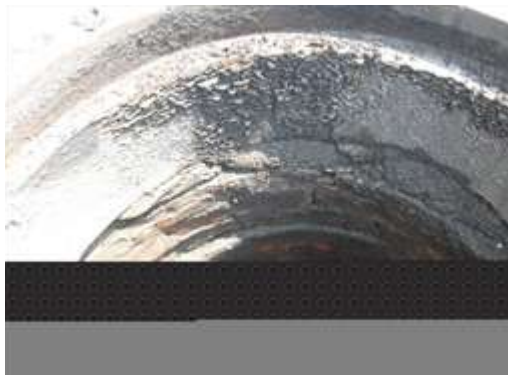
Defect 2

lid frame infiltration

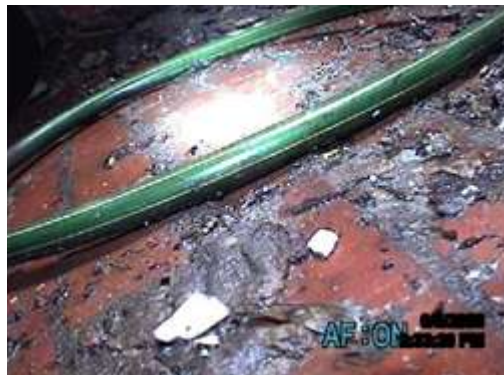
Defect 1

Condition: ☐ Sound ☐ Cracked ☐ Root Intrusion ☐ Deteriorated ☐ Leaks ☒ **Debris**

debris on bench

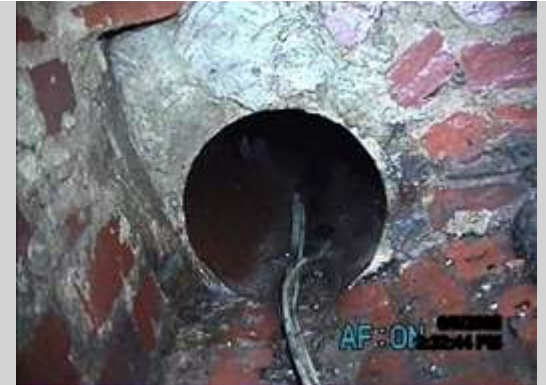
12 O'Clock Outflow

8 in. Circular Gravity Sewer  
Pipe Out @ 12 O'Clock

Pipe Height: **3.6** (in.) Direct (Angled)

Pipe Material: **Clay** ☐ Pipe Lined

Invert Depth: **9.10** (ft.) Flow Characteristics: **None**

Deposits: ☒ None ☐ Mud ☐ Sludge ☐ Debris ☐ Grease

Infiltration: **None** Pipe Seal Cond: **Sound**
